# Manhole Inspection Summary

Manhole # S13S\_\_002MH

Insp Date: **1/5/09 1:55 PM**

**Location** Address: **927 Wilmington Av**

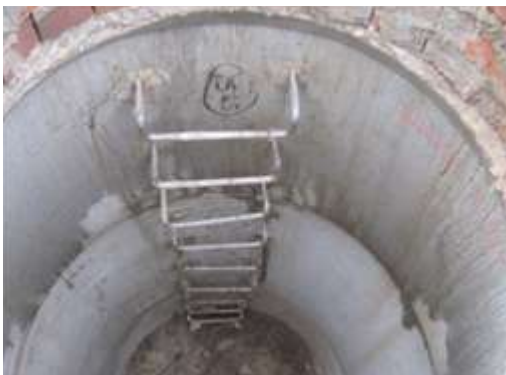
Defect 3

☒ **Leaks**

infiltration lid/frame as well as joint

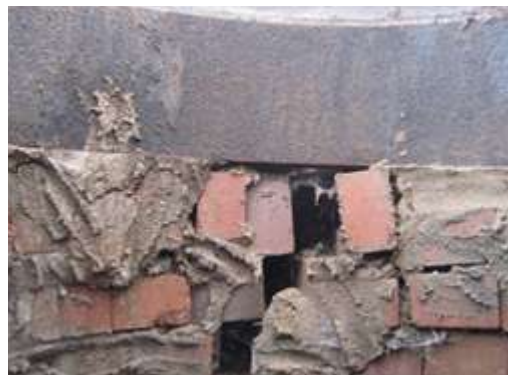
Defect 2

☒ **Cracked**

☒ **Loose Brick**

☒ **Deteriorated**

☒ **Mortar**

☒ **Wall**

missing mortar missing bricks as well as cracked

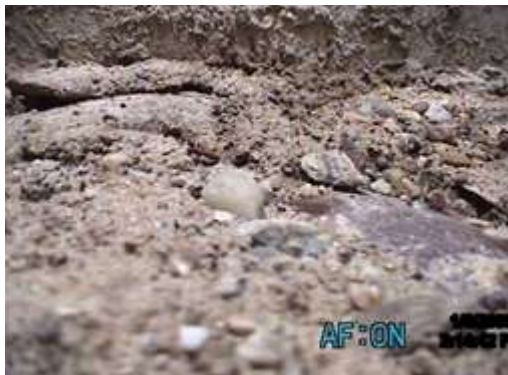
### Defect 1

☒ **Debris**

debris on bench

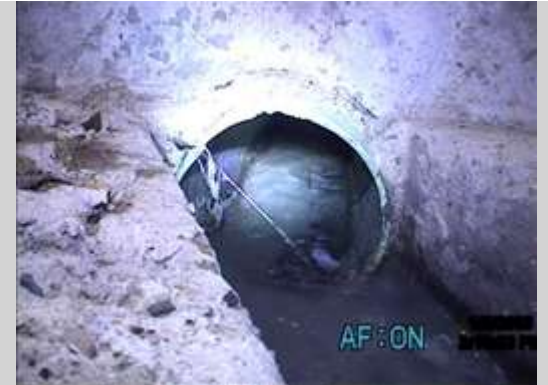
12 O'Clock Outflow

8 in. Circular Gravity Sewer  
Pipe Out @ 12 O'Clock

Pipe Height: **7.2** (in.) Rod and Bar (Angled)  
Pipe Material: **Clay** ☐ Pipe Lined  
Invert Depth: **11.11** (ft.) Flow Characteristics: **Fast**  
Deposits: ☒ None ☐ Mud ☐ Sludge ☐ Debris ☐ Grease  
Silt Depth: **0** (in.) Deposits Extent:  
Infiltration: **None** Pipe Seal Cond: **Sound**

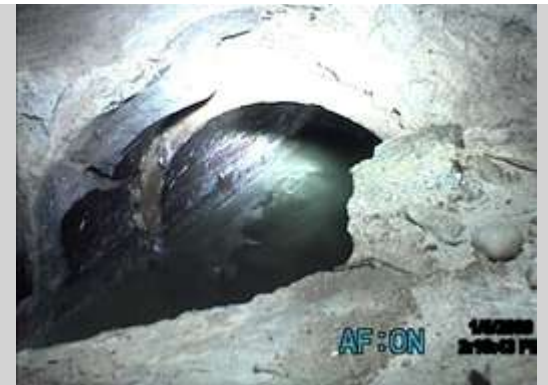
6 O'Clock Inflow

6 in. Circular Gravity Sewer  
Pipe In @ 6 O'Clock

Pipe Height: **6** (in.) Rod and Bar (Angled)  
Pipe Material: **Clay** ☐ Pipe Lined  
Invert Depth: **11.09** (ft.) Flow Characteristics: **Fast**  
Deposits: ☒ None ☐ Mud ☐ Sludge ☐ Debris ☐ Grease  
Silt Depth: **0** (in.) Deposits Extent:  
Infiltration: **None** Pipe Seal Cond: **Sound**
